Assessing Mangrove Forests, Shoreline Condition and Feasibility of REDD for Kien Giang Province Vietnam

The University of Queensland, Australia

JULY 2010

**Assessment of Mangrove Forests, Shoreline Condition and Feasibility for REDD
in Kien Giang Province, Vietnam**
A Technical Report

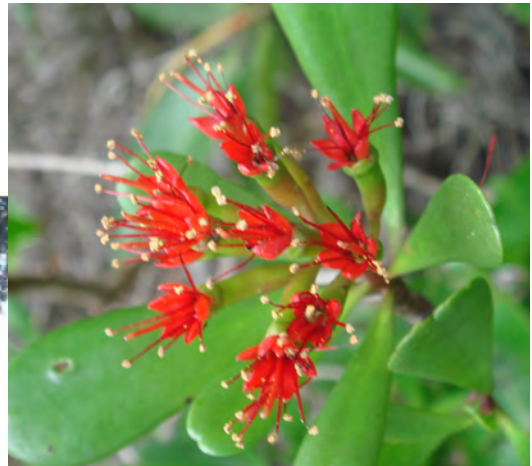
Figure 2: *Lumnitzera littorea* in Phu Quoc Island. A particularly large individual – 16 m tall, and 250 cm girth. All have showy and attractive bright red flowers.

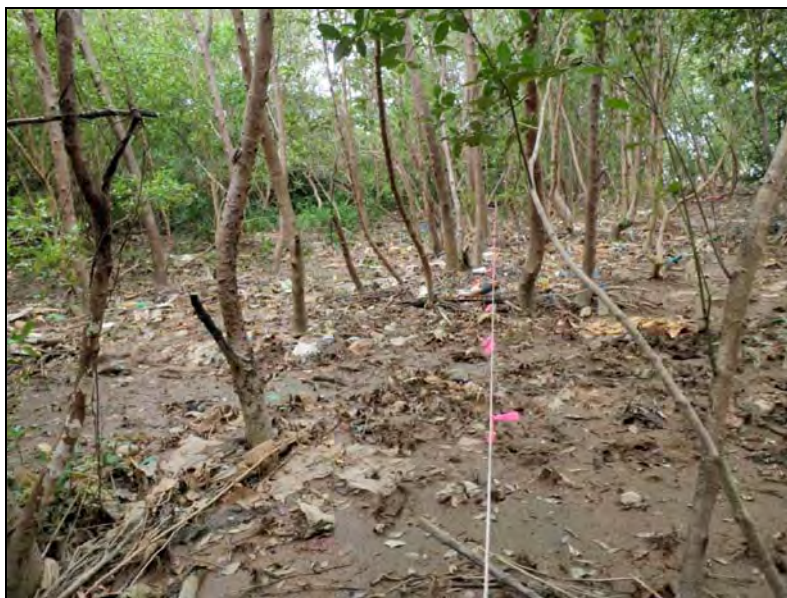
Figure 3: Young ocean front forest dominated by small *Avicennia alba*, Vam Ray.

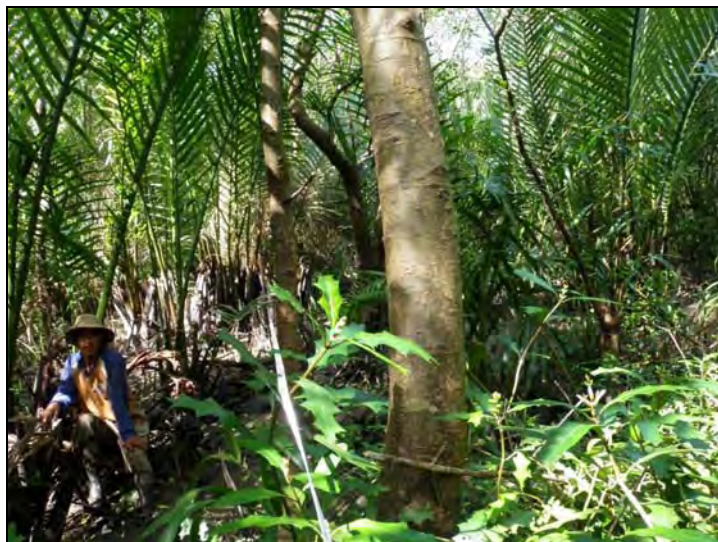
Figure 4: 'Mixed' mangrove forest, with *Avicennia alba* in centre larger than that shown in Figure 3.

- With distance from the sea, a more 'mixed' mangrove develops at mid to high tide levels where a number of other species colonise after the first development of mangrove vegetation, joining the initial species (Figure 4). This is the richest type in terms of biodiversity and can develop dense, stable vegetation, with some of the biggest trees. *Avicennia* is still a major component. Hong & San (1993) refer to this vegetation as an *Avicennia alba*-*Rhizophora apiculata* community, which is appropriate, but other species such as *Bruguiera* spp. (Vet), *Xylocarpus* spp. (Xu) and *Sonneratia alba* (Bàn trắng) also appear.

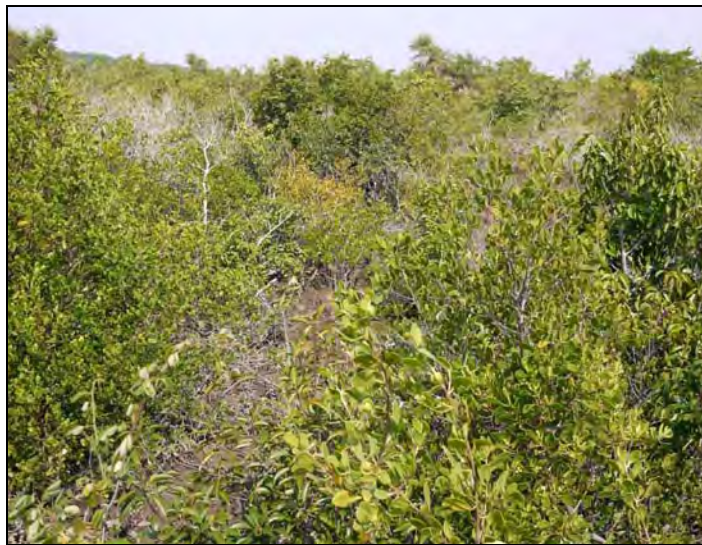
- In the northern areas of Kien Luong and Ha Tien Districts, stands of an upper intertidal 'scrub' of about 2-3 metres height and good diversity are present (Figure 5). Plants such as *Scyphiphora hydrophyllacea* (Côi), *Lumnitzera littorea* (Cóc đỏ) and *L. racemosa* (Cóc vang) that are rare or absent elsewhere in Kien Giang are present, along with commoner species such as *E. agallocha*. South of Kien Luong, the mangrove forests are typically too narrow to support this vegetation.

Figure 5: Scrubby open mangrove vegetation at high intertidal levels in the Giang Thanh River system, Ha Tien. Although always short, the openness and height of this site partially reflects cutting.

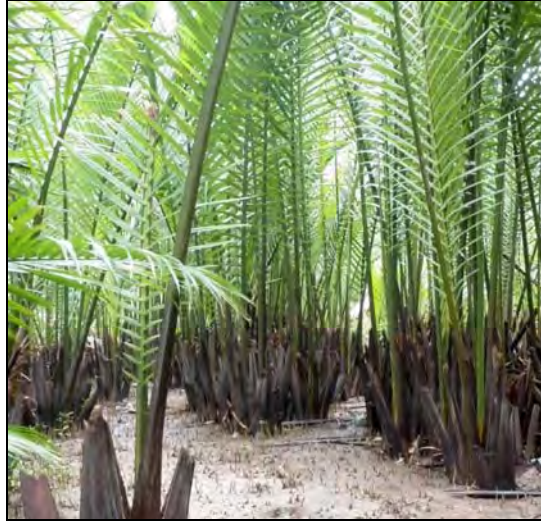
- Stands of the palm *Nypa fruticans* (Dừa nước) can be present at the rear of the mangrove on the coast, or at the front along canals or rivers (Figure 6). There are natural occurrences, although many are planted, even on a small scale, due to the utility of their leaves and, to a lesser extent, their fruit. There are some relatively large planted areas along rivers and widespread planting at the rear of the mangrove, seemingly including the replacement of other mangrove trees in at least a few places.
- Fringing strips of mangrove 'associate' species are present at the rear of the tidal influence, with characteristic species such as *Hibiscus tiliaceus* (Tra nhót) and *Thespesia populnea* (Tra bồ đề) and numerous others. This is a typical situation.

Figure 6: Stand of *Nypa* palms showing cutting of fronds and clumping habit, Vam Ray.

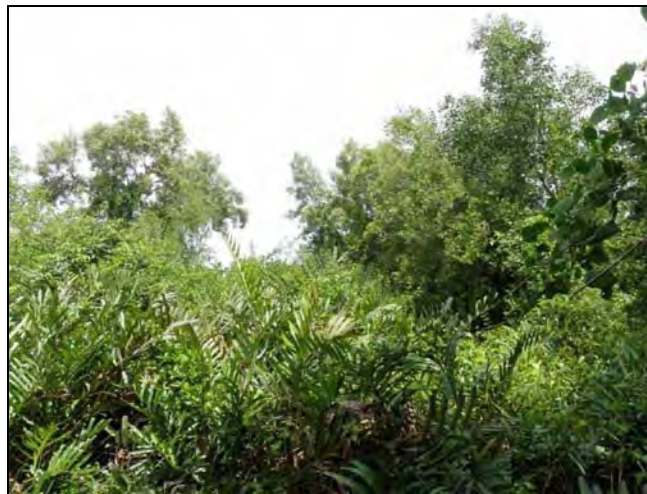
Figure 7: *Acrostichum* and *Clerodendrum* thicket and scattered trees, Plot VRy1, Vam Ray. This should all be forest. The very dense thicket can suppress tree regeneration.

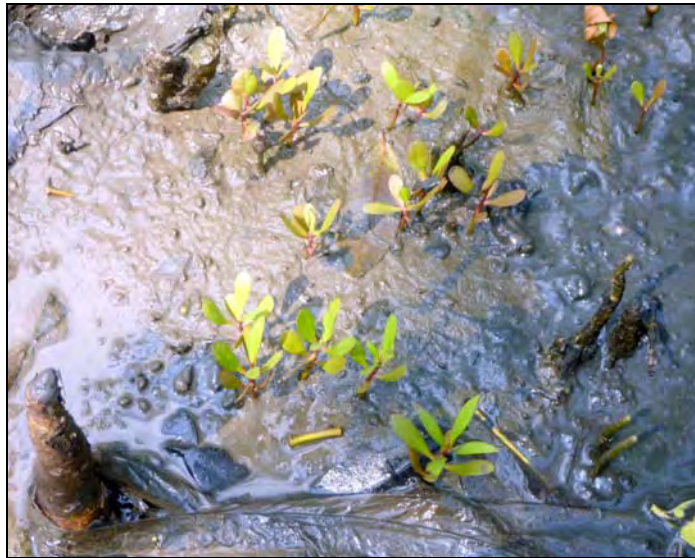
Figure 8: *Sonneratia caseolaris* seedlings, Vam Ray. Regeneration is present throughout the mangrove.

- Natural mangrove regeneration is generally very good within the forest area (e.g. Figure 8) and is not a problem overall in Kien Giang, although some species may be restricted more than others.

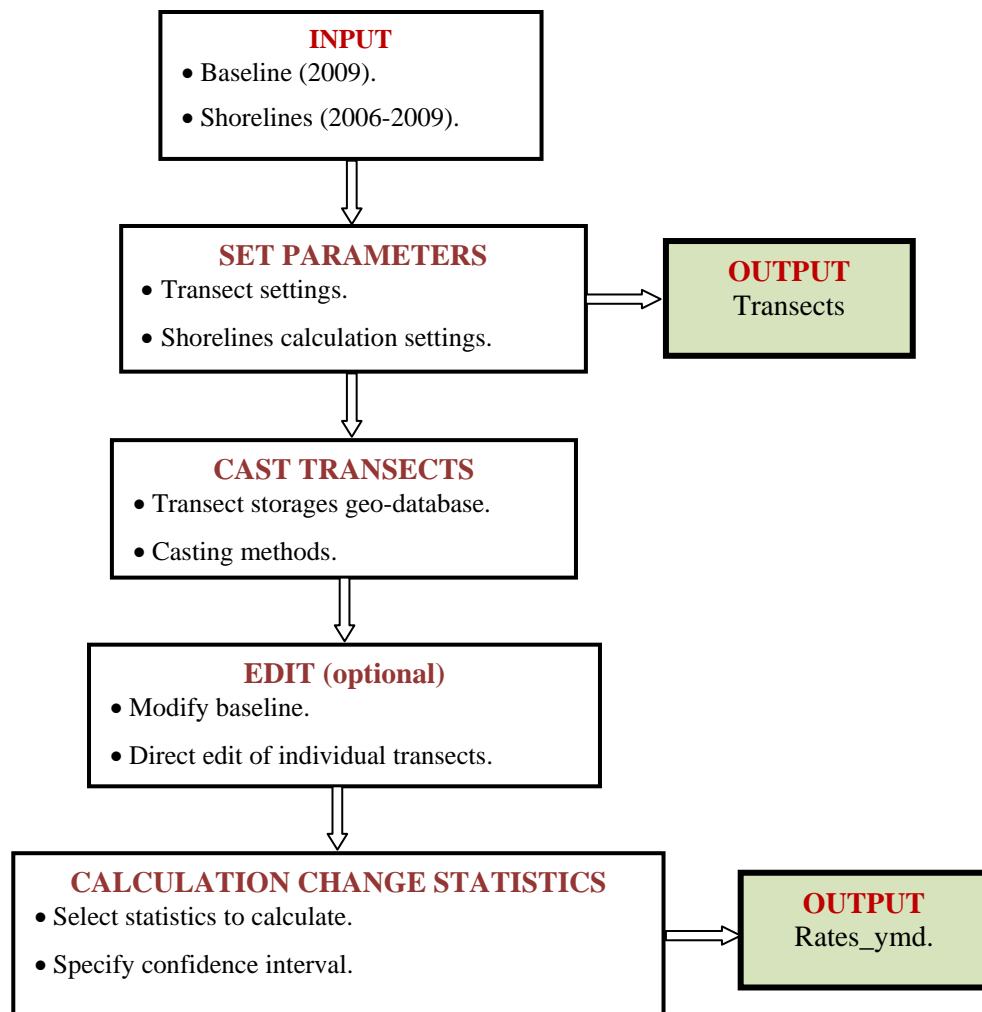
Figure 10: Flow diagram showing the process of historical shoreline interpretation

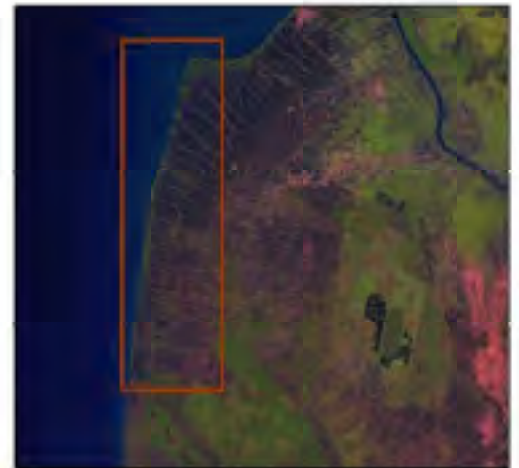
We present preliminary evidence of significant coastal erosion in key sections of the coastal margin of Kien Giang province. In this, note the progression of extrapolated coastlines for 1992, 2006, 2007 and 2009 where there is a steady retreat landward in Hon Dat district. The rate of coastline retreat is estimated at up to 24 m per year, as shown in Figure 16.

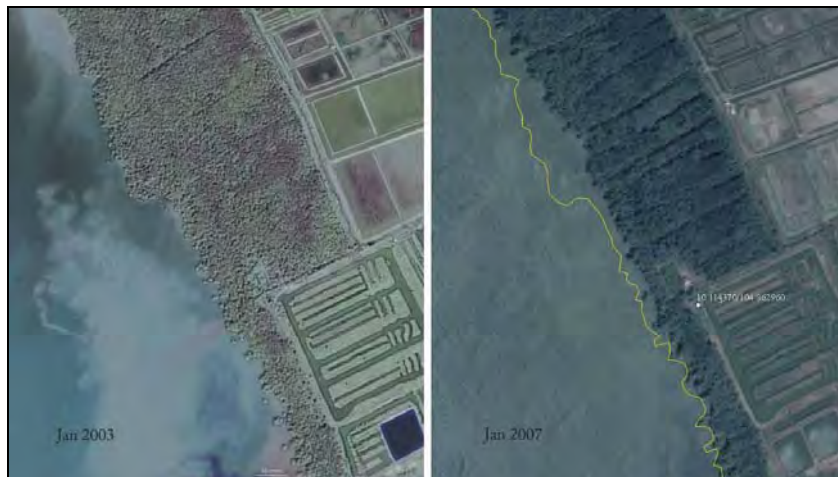
A dramatic feature of the sea-edge mangrove vegetation in Kien Giang is the degree of erosion that is occurring, both in terms of depth of mangrove being lost and the length of coast affected. The rate can be very rapid. Figure 16 shows shoreline changes in the Hon Dat region since 1992, and Figure 17 shows approximate retraction at one site near Hon Queo between 2003 and 2007.

Figure 17: Mangrove retraction between 2003 and 2007 at Hon Queo. Yellow line represents 2003 mangrove front. Note canals cut through forest between dates, plus further loss since 2007 (not shown) (Image: Google Earth).

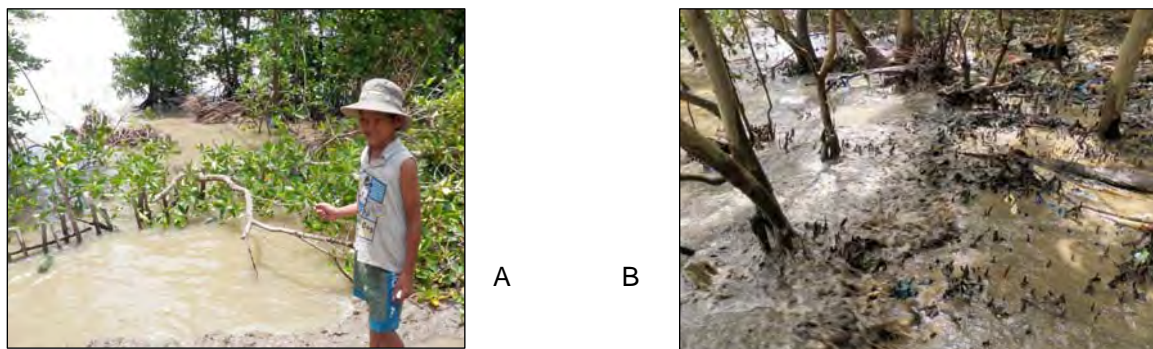
The worst affected areas in Kien Giang are those of relatively straight open coast, where the mangrove fringe is often thinnest (see Figures 11 - 15). It is well known that open coasts where fringing mangroves have been lost are subject to erosion by sea waves (Mazda *et al.* 2002). Sea-front erosion, including sites with mangroves, is widespread in Vietnam, with very high rates of erosion in places (> 30 m per annum) (Cat *et al.* 2006). Figure 18 shows a localised break-through on to a small dyke enclosing a pond built into the mangrove area in An Bien and wave action in an eroding forest in Vam Ray.

Figure 18: (A) Sea broken through the thin remaining mangrove fringe, threatening the small dyke enclosing aquaculture pond, An Bien; (B) Waves washing into the eroding front of *Avicennia alba* forest, Vam Ray.

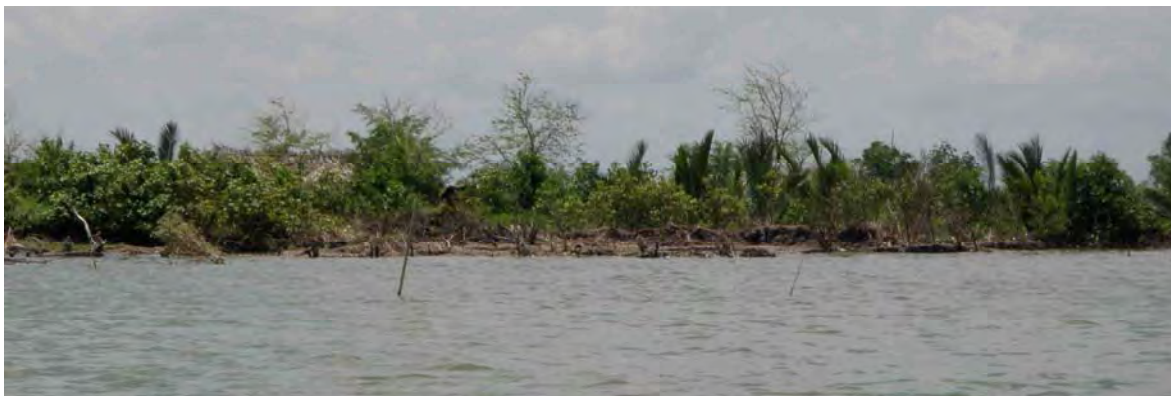
Figure 21: Actively eroding mangrove, Kien Giang province, Vietnam.

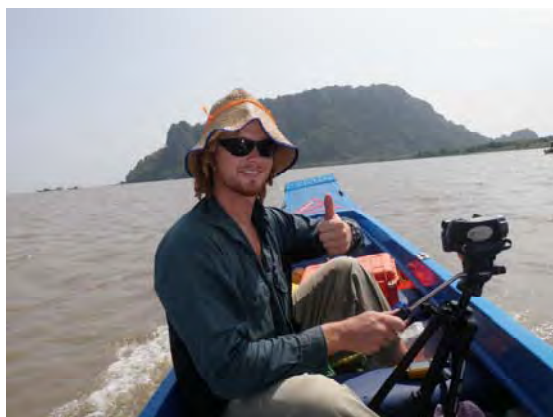
Figure 22: Recording video imagery of the coastline: ~180 km and many hours.

A video of the shoreline was taken using a Sony Handycam from a boat running parallel to the coastline approximately 25m from the shore (Figure 22). A GPS was used to record latitude and longitude every 3 seconds. Both the GPS and Handycam were set to the exact same time.

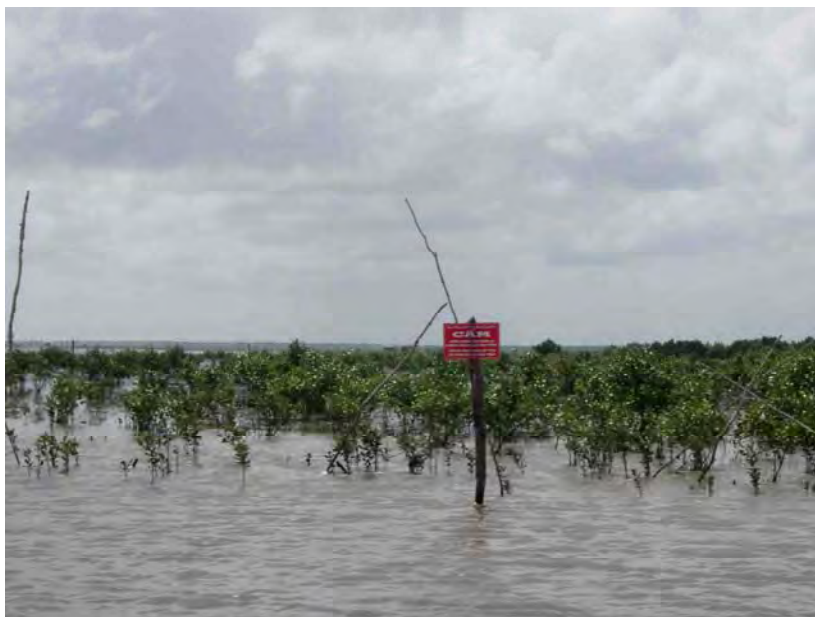
Mangrove planting activities in Kien Giang generally occur behind a mangrove planting fence, consisting of rows of two stakes crossed to form an X. Areas with dense to moderate seedling/sapling cover present behind the 'planting fence', were recorded as successful planted areas. Areas with few or no seedlings/saplings present behind the fence were considered to be unsuccessful planting areas.

Figure 23: Recently planted mangroves in An Bien region. Note planting fence on the right

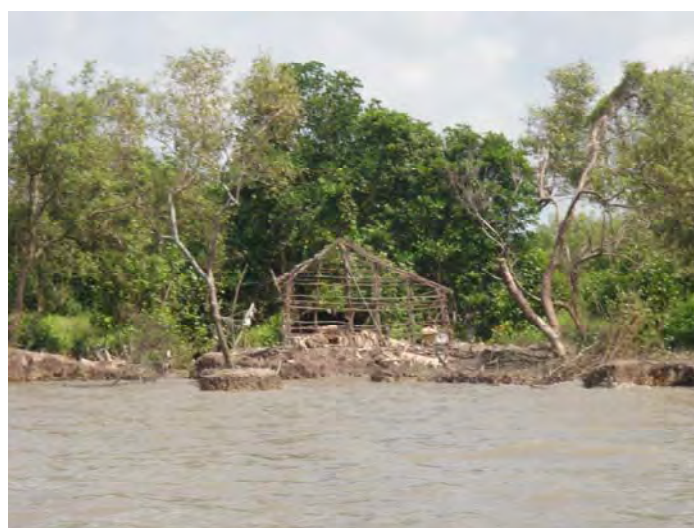
Figure 24: Much of the mainland coast of Kien Giang province is eroding, observed by falling trees, exposed roots, undercut banks, and abandoned houses.

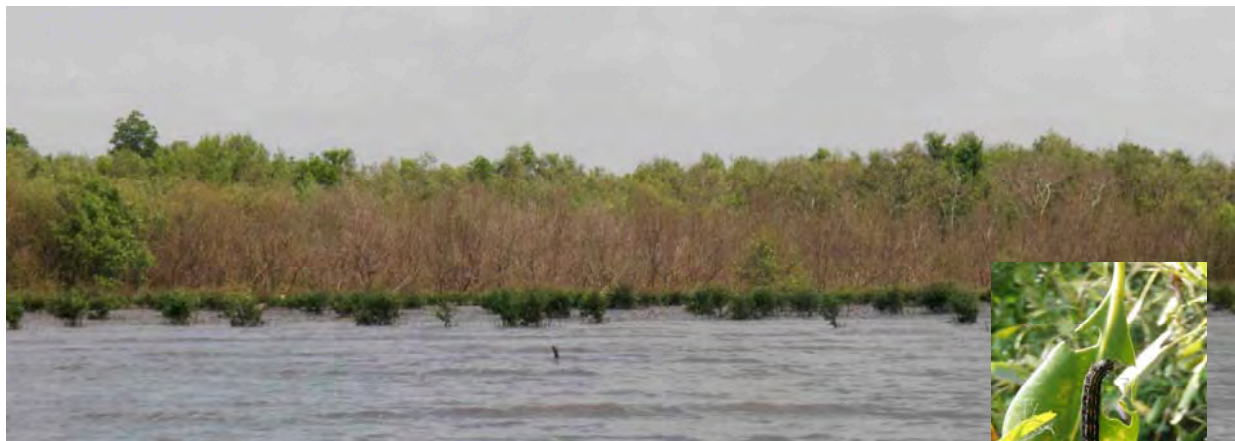
In addition to wood harvesting, a number of other natural and anthropogenic pressures were identified from the shoreline survey that are likely to further reduce the resilience of the mangrove forest to coastal erosion. Most notable of these pressures was the unexpected occurrence of severe herbivory on *Avicennia* from an unidentified caterpillar, causing extensive foliar leaf loss (Figure 75). This effect was observed in 10% of mangrove areas, mostly in An Bien and An Minh districts and in planted, prograding forest (Figure 69). The extensive damage to young planted *Avicennia* indicates that mixed species planting should be utilized to increase stand resistance to such an event.

Figure 75: Intense insect herbivory on mangrove trees is a fairly common occurrence on the Kien Giang Shoreline. Inset (right): Unidentified caterpillar grazing on Mangrove leaves. Both photographs taken in An Minh District.

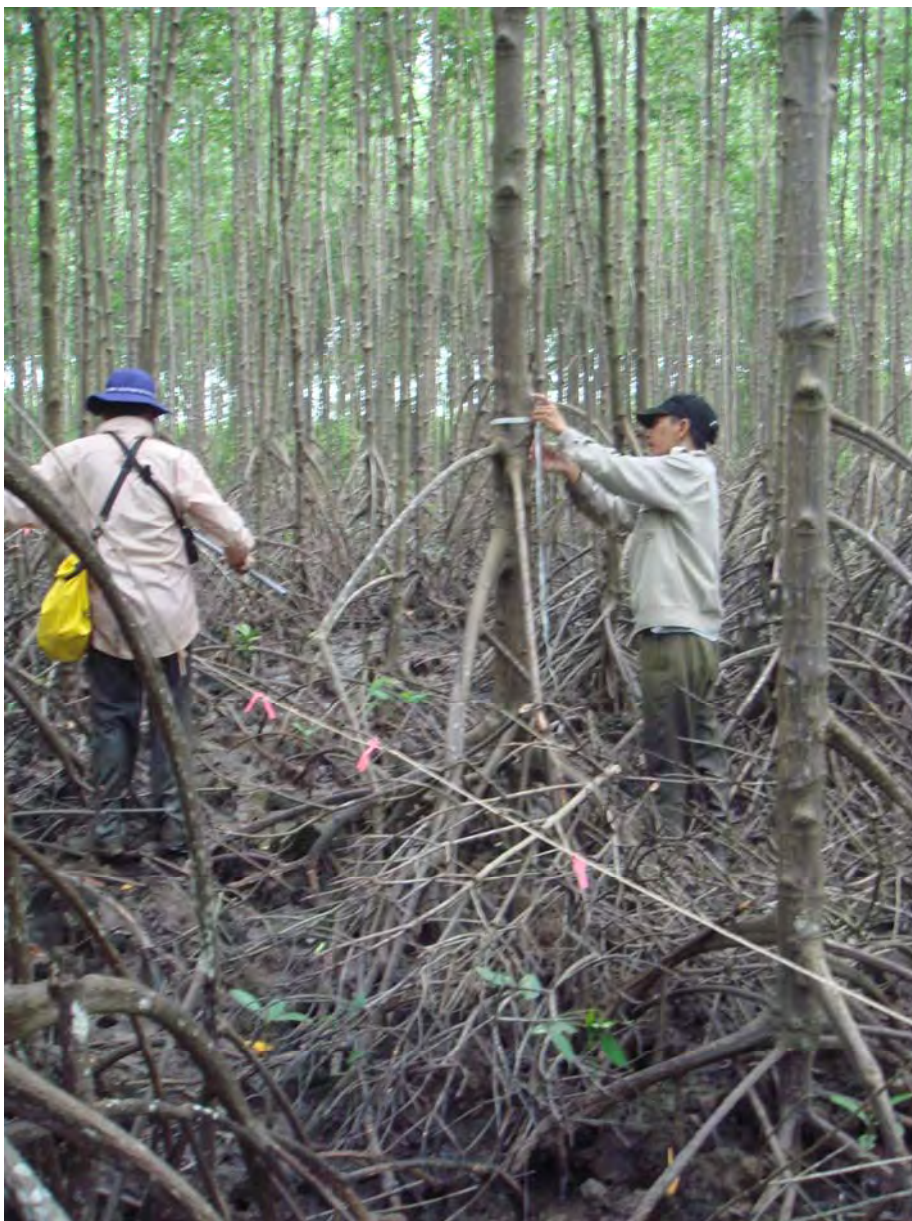
Figure 76: Measuring plots for mangrove biomass estimates.

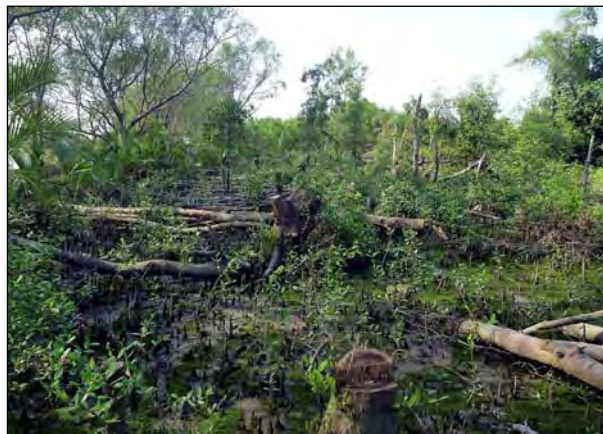
Figure 77: Recent large scale cutting of mature *Sonneratia caseolaris* for coppicing. Note large stump in foreground. Cutting such trees has large biomass implications.

It is obvious that human influences on mangrove forest quality (such as cutting) substantially impact the carbon storage potential of the forest (Figure 77). **To enhance the level of biomass, and subsequent carbon storage within mangrove forests in Kien Giang, efforts to protect the forest will be worthwhile.** We estimated current total forest biomass in Kien Giangs mangrove forests (based on extrapolation of mangrove area mapping in chapter 2) to be 549114 ± 57385 t DW (± 1 std error of the mean). This corresponds to 269089 ± 28120 tonne of carbon storage. If, through protection, restoration and rehabilitation, mangrove forest biomass were to reach levels in line with primary forest biomass of nearby Thailand, total forest biomass could increase to as much as 1999900 t DW (given a total biomass level of 571.4 t DW ha⁻¹). **This in an increase of 1450785 t DW, which is more than 3.5 times the level of mangrove forest biomass we see today, with no increase in the area of mangrove in Kien Giang.**

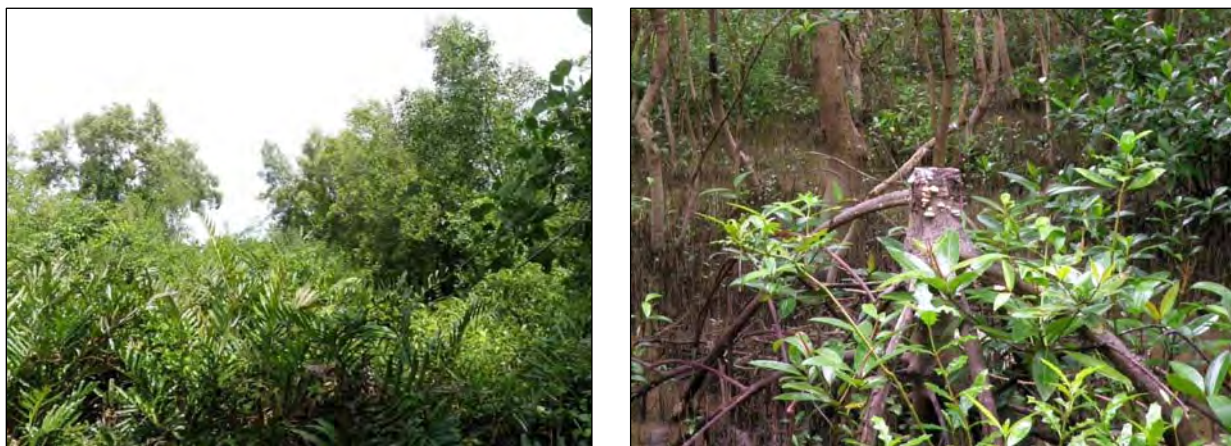
Figure 78 (left): *Acrostichum* and *Clerodendrum* thicket and scattered trees, Plot VRy1, Vam Ray. This should all be forest. The very dense thicket can suppress tree regeneration. **Figure 79** (right): Stump of mature *Rhizophora apiculata* within mixed forest, An Bien. Cutting trees of this relative size noticeably affects standing biomass

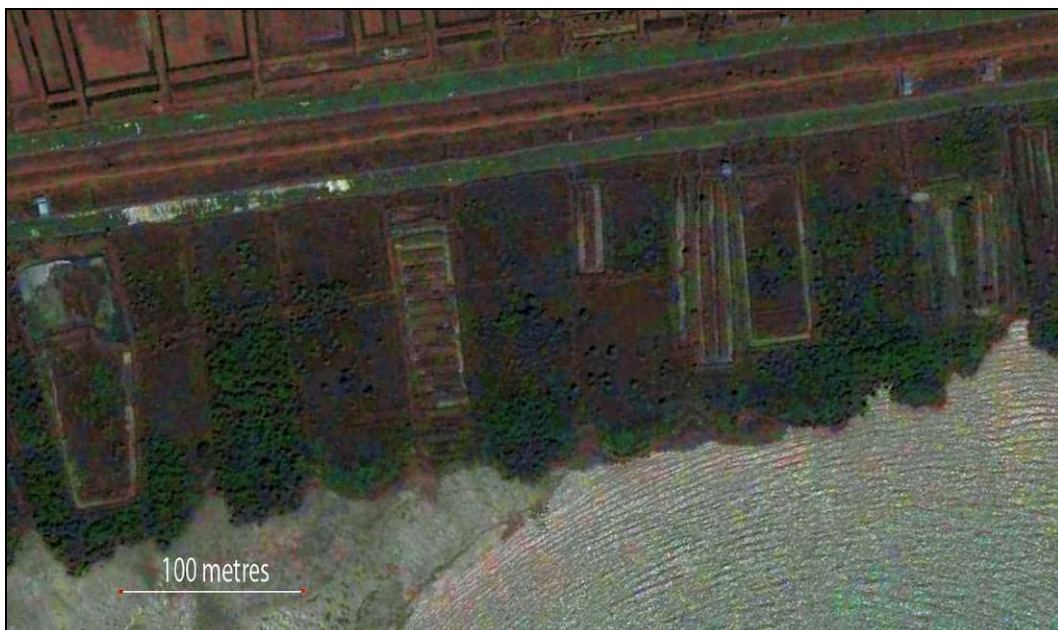
Figure 80: Degraded mangrove with unused aquaculture ponds, Kien Luong. Note a lack of tree cover and the eroding front of the mangrove. Erosion appears apparent even where mud extends out to sea (left of picture) (Image: Google Earth). The thickets in the non-treed areas may be suppressing regeneration.

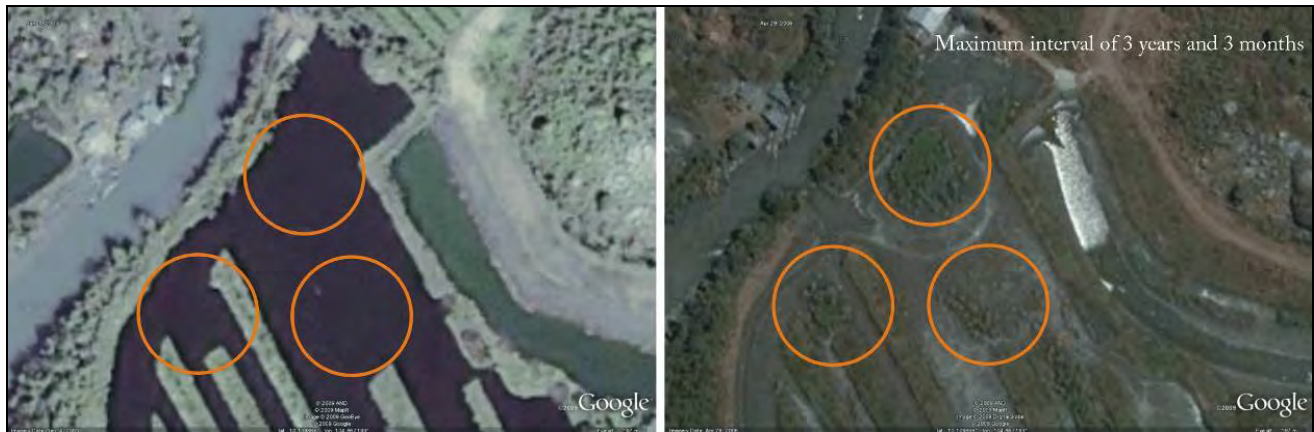
areas there is great potential in natural regeneration if tidal conditions were enhanced. This includes existing and former aquaculture ponds and degraded land. Figure 81 shows where a breach of a wall immediately south of Hon Queo canal has reintroduced tidal flow, resulting in natural mangrove regeneration. The intervening period of a maximum of about 39 months has resulted in regeneration sufficiently large to be visible by remote sensing.

Figure 81: Apparent natural regeneration of mangrove vegetation following reintroduction of tidal regime to ponds, Hon Queo (Image: Google Earth).

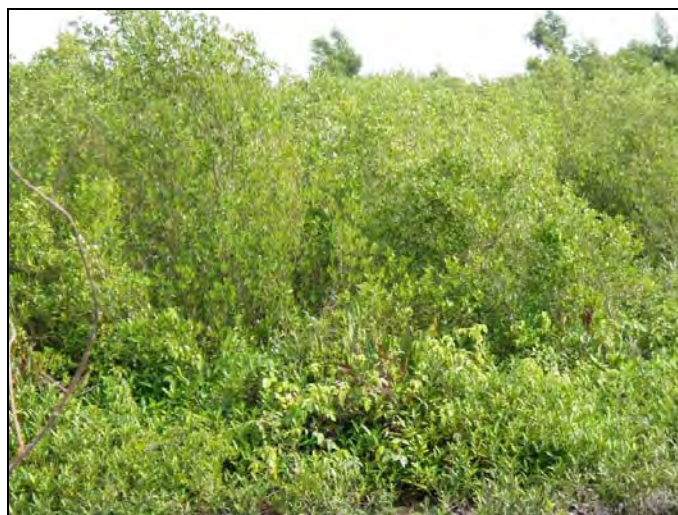
Figure 82: Young natural regeneration of *Avicennia alba* in former pond, Vam Ray

Figure 82 shows young natural regrowth of *A. alba* at Vam Ray, in a abandoned aquaculture pond. Tidal flow is sufficient to instigate regeneration, which is rapid. Such regeneration is relatively low in biomass, similar to *A. alba* forest at the front of the mangrove, but will build over time. The advantages in natural regeneration are that it is low in resources compared to planting and that natural biodiversity is generated. The disadvantage compared to planting is that in good sites plantation growth is often faster.

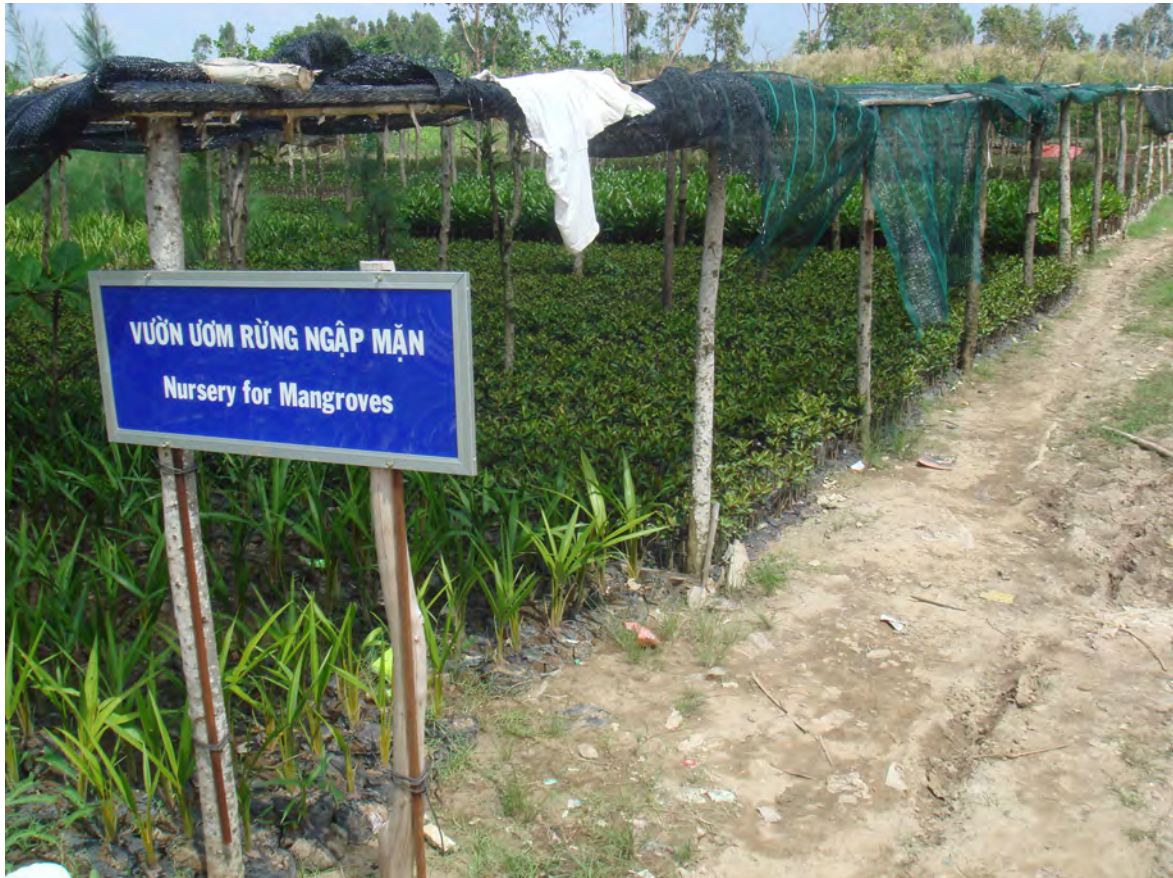
Figure 83: Nursery for growing mangrove seedlings and preparing them for planting in both sea margin protection, and mangrove livelihood trials.

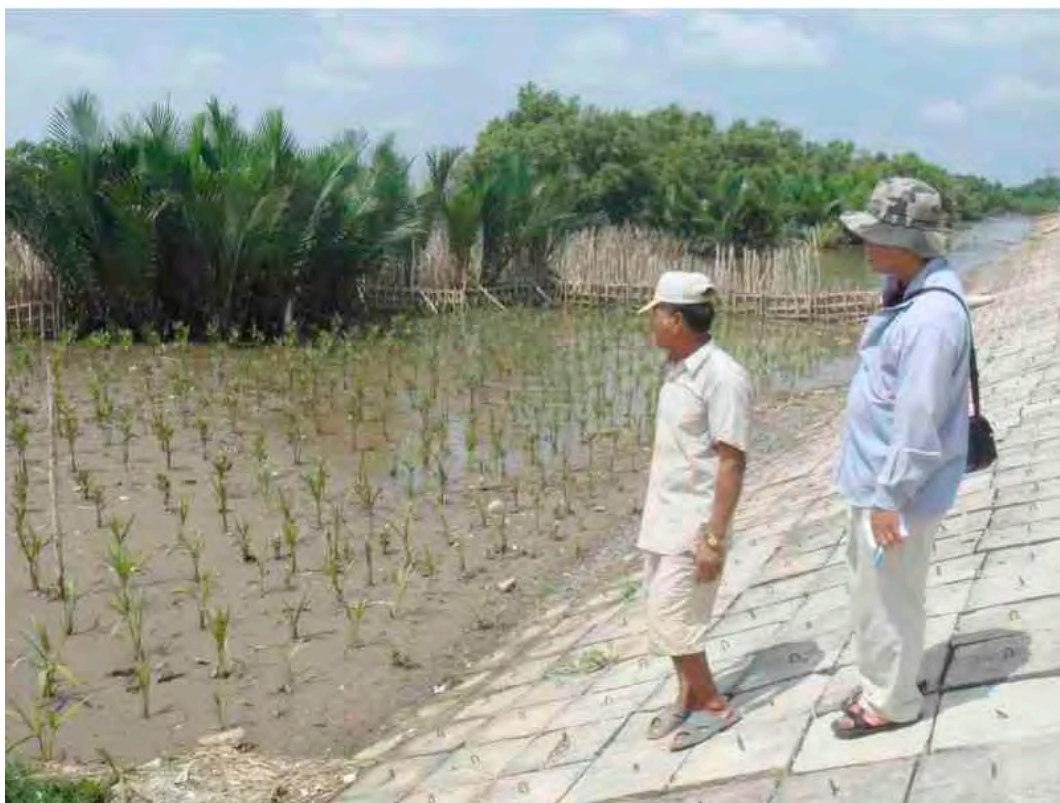
Figure 84: Planting trials will consolidate various on-ground works to restore the Hon Dat sea wall and fringing mangrove defences.

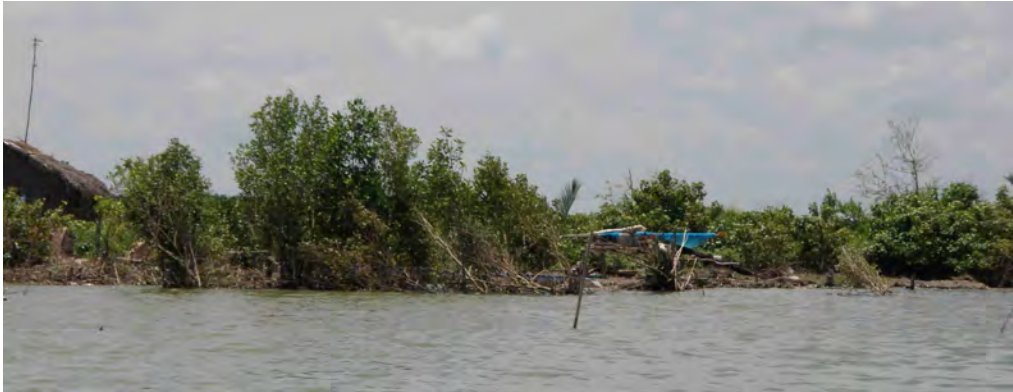
Figure 86: Eroding coastlines threaten homes and livelihoods in many regions of Kien Giang province.

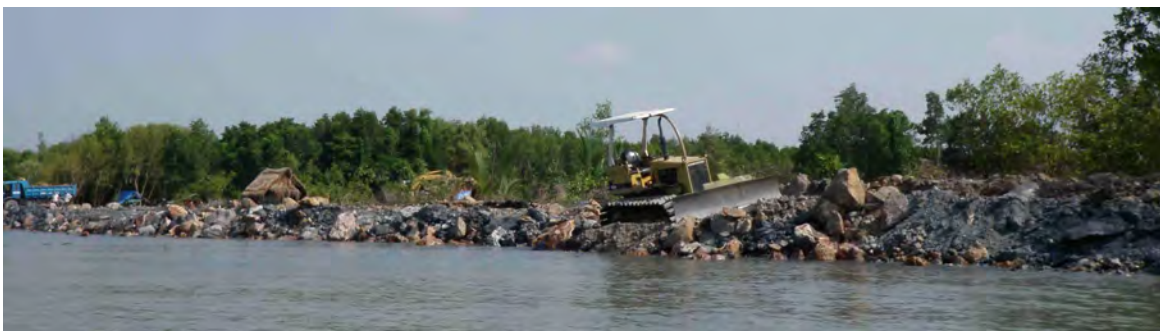
Figure 87: Mangrove destruction for the creation of a new dyke and canal, Kien Luong.

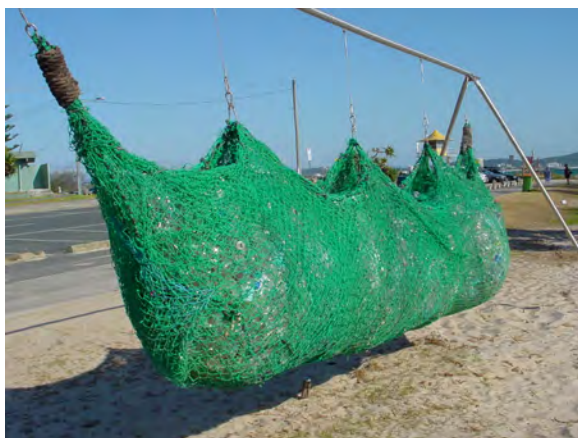
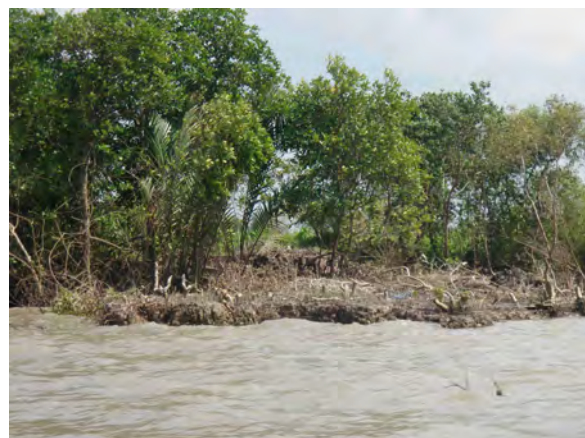
Figure 88: Recycled fish nets full of plastic bottles (left) could be used to provide protection to mangrove seedling planting areas where high wave action prevents seedlings becoming established (e.g right figure).

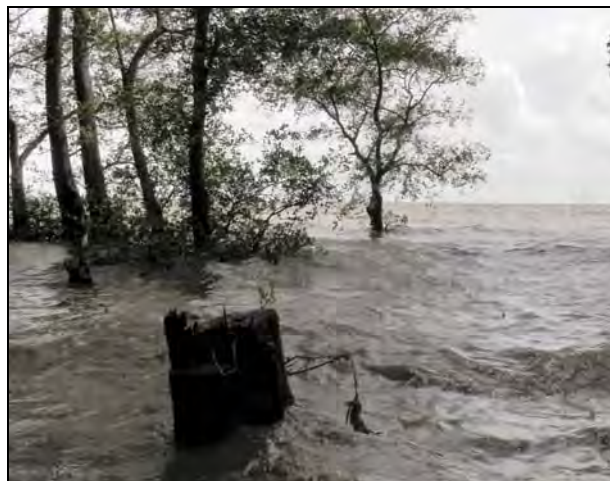
Figure 90: Large *Sonneratia caseolaris* stump, Vinh Quang. This site is eroding.

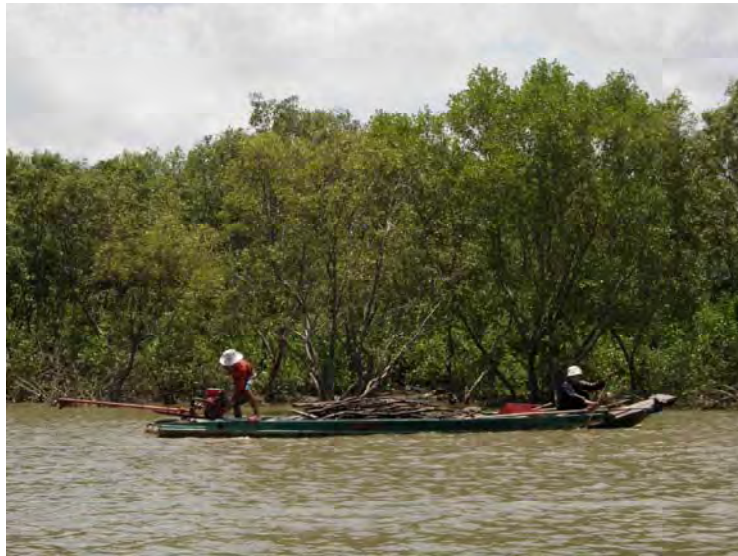
Figure 91: Mangrove destruction through cutting continues throughout Kien Giang province due to lack of alternate sources of firewood and building material and limited understanding of the importance of mangrove habitats
